**Flood Control Project Maintenance
Levee Inspections**

Fall 2016 Levee Maintenance Deficiency Summary Report

Reclamation District No. 0070 Meridian

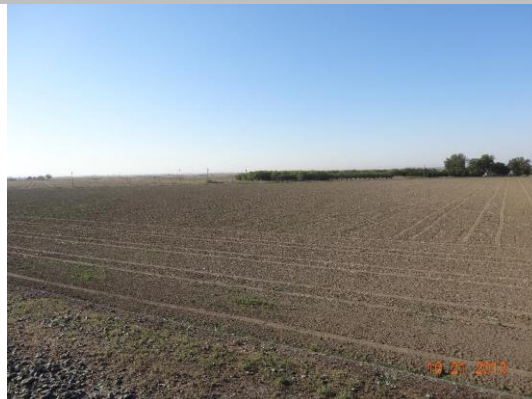
Photo 2 of 2 : UCIP_FA_2016_23463_40621.jpg

FS_ID:23463
DS_ID:21347
EP_NO: 3804
Repair Type: Non-Urgent
Crossing Status: Indicator Found
UCIP Comments: Unable to confirm if the indicators that were found in the field correspond to this crossing. Will need to contact PG&E to confirm location of crossing. Photos will need to be updated if the photos attach do not correspond to this crossing. This crossing is referenced in the USACE Periodic Inspection as item USACE_CESPK_MRD1_2012_p_0304 for 12 inch gas pipe. Coordinates between DWR UCIP and USACE PI are approximately 630 feet apart.
FIELD_STRUCT_DESC: 12-inch steel gas pipe through the levee, 3.6 feet below the crown. Concrete cutoff wall around pipe at center of levee. Marker sign on waterward shoulder. Rock revetment on waterward slope. (Permit No. 3804-1961)
FS Date: 10/21/2013

View of landward side where gas line markers are visible approximately 900 feet from levee.

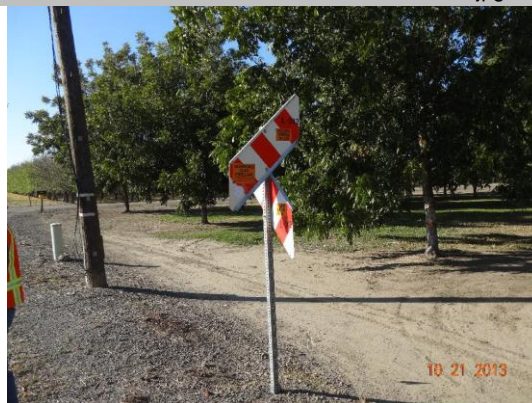
Photo 2 of 2 : UCIP_FA_2016_23384_40247.jpg

LM Start	0.55	Rating **	M	Issue No.	42
LM End	0.55	Issue Type +	En	Location *	WS
Category	Supplemental			GPS Latitude/Longitude	
				Start	End
Item	DWR UCIP Field Study			39.142565 °	39.142565 °
				-121.841600 °	-121.841600 °
DWR ID					
Comment Code					
Inspector Comment					
FS_ID:23384 DS_ID:21415 EP_NO: 15936 Repair Type: Non-Urgent Crossing Status: Indicator Found UCIP Comments: No markers visible on levee slope or levee toe to indicate line crosses levee. Need to contact PG&E to confirm location through levee. Also need to confirm the emergency contact person for this crossing. FIELD_STRUCT_DESC: 8-inch steel pipe through the levee, 2.5 feet below the crown. Gas line markers on the landward side. (Permit No. 15936-2005) FS Date: 10/21/2013

View of markers on the west side of S. Tarke Road.

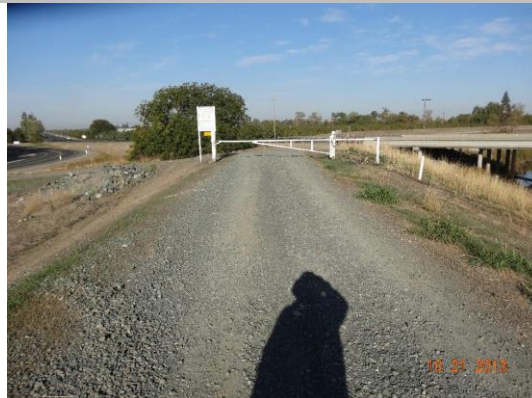
Photo 2 of 2 : UCIP_FA_2016_23503_40780.jpg

FS_ID:23503
DS_ID:21351
EP_NO: 3686
Repair Type: Non-Urgent
Crossing Status: Found
UCIP Comments: Dense vegetation limits the inspector's visibility to identify signs of pipe failure (leaks) along the waterward slope. Recommend removing vegetation along pipe alignment to conduct proper inspection of structure and appurtenances. Unable to find the gate valve on landward side. Walkway on waterward side in bad shape. This crossing is referenced in the USACE Periodic Inspection as item USACE_CESPK_MRD1_2012_p_0300 for 18 inch pipe. Pipe on LS is 10 inch not 18 inch. SEE UCIP DS_ID 21350 for details pertaining to 18 inch pipe.
FIELD_STRUCT_DESC: 10-inch pipe and electrical conduit through the levee, 14.8 and 1.0 feet below the crown, respectively. Gate valve on landward end--not found during 10/21/13 pipe inventory. Pump on pile structure in stream. Walkway to slide gate on waterward end. Rock revetment on waterward slope. Pump and concrete support piers at waterward toe installed under Permit No. 3686 (1963). Service pole with meter and control panel at landward toe.

View of levee crown looking downstream.

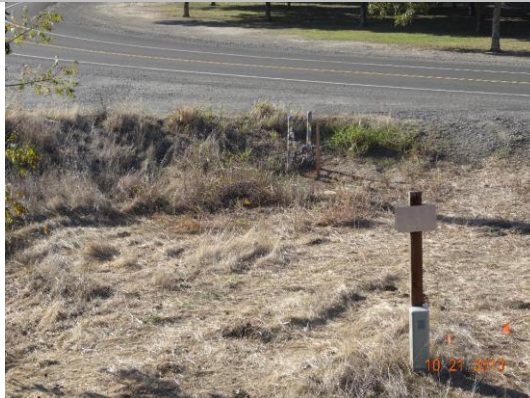
Photo 2 of 2 : UCIP_FA_2016_23467_40641.jpg

FS_ID:23467
DS_ID:21354
EP_NO: 14802
Repair Type: Non-Urgent
Crossing Status: Indicator Found
UCIP Comments: Need to contact owner to determine status of crossing. Need date of last inspection and confirmation that crossing is still in operable condition. Markers found about 159 feet upstream of coordinates at the crossing of the ramp and S. Tarke Road (39.142684, -121.842685).
FIELD_STRUCT_DESC: 4-inch steel gas pipe through the levee, 2.5 feet below the crown. Aluminum pipe marker on landward slope. (Permit No. 14802-1987) Contact emergency information for Pacific Gas & Electric Company 1-800-344-4749? 4742? or 1-916-742-3251.
FS Date: 10/21/2013

Additional appurtenances for gas line located at landward side near S. Tarke Rd.

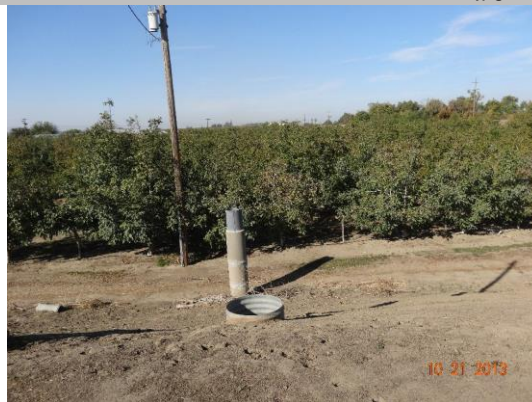
Photo 2 of 2 : UCIP_FA_2016_23526_40941.jpg

Comment Code					
Inspector Comment					
FS_ID:23526 DS_ID:21355 EP_NO: 9961 Repair Type: Non-Urgent Crossing Status: Found UCIP Comments: Dense burrow activity present on both waterward side and landward side. Recommend addressing burrow activity at this location. Also recommend having owner clear vegetation blocking access along walkway. This crossing is referenced in the USACE Periodic Inspection as item USACE_CESPK_MRD1_2012_p_290. FIELD_STRUCT_DESC: 10-inch (not 12-inch as noted in desk study) steel pipe through the levee, 5.4 feet below the crown. Siphon breaker in CM pipe riser on landward slope. 24-inch concrete standpipe at landward toe. Walkway to pump on pile structure in stream. This pipe was retained under ABO No. 9961 (1974). FS Date: 10/21/2013

View of standpipe and CMP riser located on landward side.

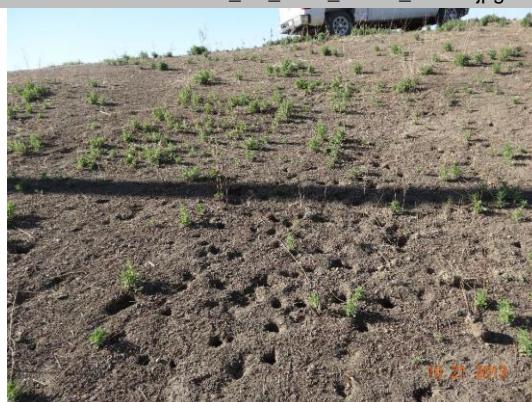
Photo 2 of 2 : UCIP_FA_2016_23508_40819.jpg

FS_ID:23508
DS_ID:21336
EP_NO: N/A
Repair Type: Non-Urgent
Crossing Status: Found
UCIP Comments: Need to find owner to determine if crossing is still in use. If crossing is no longer in use owner will need to coordinate with DWR inspector and CVFPB to remove according to Title 23 requirements. Evidence of high burrow activity on waterward side recommend addressing issue. This crossing is referenced as USACE_CESPK_MRD1_2012_p_0230 in the USACE's PI report for no USACE recommendation letter available -- correction pipe is 12-inch not 16-inch.
FIELD_STRUCT_DESC: 12-inch pipe through the levee, 4.0 feet below the crown. Siphon breaker on the landward slope. Concrete distribution box (7 ft by 9 ft) at landward toe. Service pole on waterward slope. Pump on concrete sump on waterward slope. Overhead power line crosses levee at location. This pipe was retained under ABO No. 9948 (1974) issued to Edward E. and Doris M. Nall. Permit No. 613 issued in May 29, 1934 is for 12 inch pipe issued to Waldo Nall.

Dense burrow activity found on waterward slope.

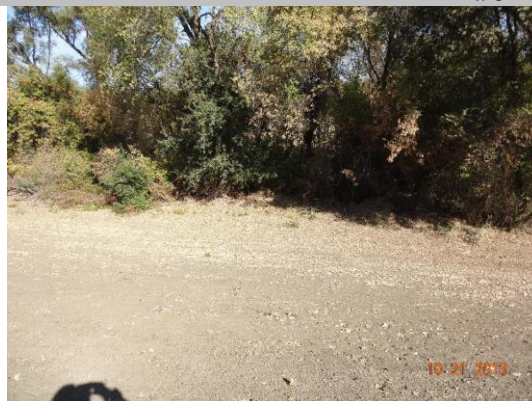
Photo 1 of 2 : UCIP_FA_2016_23530_40968.jpg

Comment Code					
Inspector Comment					
FS_ID:23530					
DS_ID:21322					
EP_NO: N/A					
Repair Type: Non-Urgent					
Crossing Status: Indicator Found					
UCIP Comments: Unable to determine if crossing exists need to coordinate with LMA to determine if more information is available about crossing. This crossing is referenced in the USACE Periodic Inspection as item USACE_CESPK_MRD1_2012_p_0208 for concrete ditch lined within 15 feet of LS toe, no water present, and no USACE recommendation letter available.					
FIELD_STRUCT_DESC: 12-inch steel pipe through the levee. Cutoff wall around pipe at center of levee. Two slide gates, on each end of pipe. Pump on waterward side. Concrete distribution box on landward side. (USACE-1953). This entry matches the Drainage or Irrigation Structure referenced in O&M manual (Station 142+70).					
FS Date: 10/21/2013

View of waterward side.

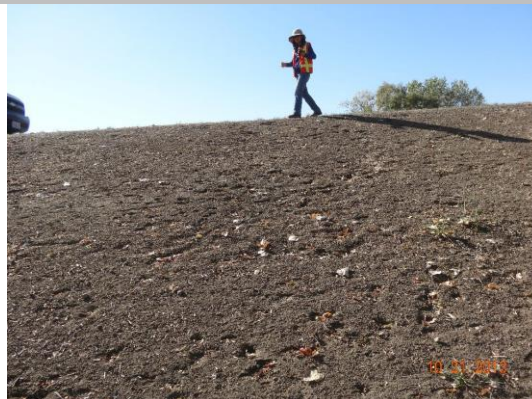
Photo 2 of 2 : UCIP_FA_2016_23530_40972.jpg

Comment Code						
Inspector Comment						
FS_ID:23530 DS_ID:21322 EP_NO: N/A Repair Type: Non-Urgent Crossing Status: Indicator Found UCIP Comments: Unable to determine if crossing exists need to coordinate with LMA to determine if more information is available about crossing. This crossing is referenced in the USACE Periodic Inspection as item USACE_CESPK_MRD1_2012_p_0208 for concrete ditch lined within 15 feet of LS toe, no water present, and no USACE recommendation letter available. FIELD_STRUCT_DESC: 12-inch steel pipe through the levee. Cutoff wall around pipe at center of levee. Two slide gates, on each end of pipe. Pump on waterward side. Concrete distribution box on landward side. (USACE-1953). This entry matches the Drainage or Irrigation Structure referenced in O&M manual (Station 142+70). FS Date: 10/21/2013

View of waterward slope.

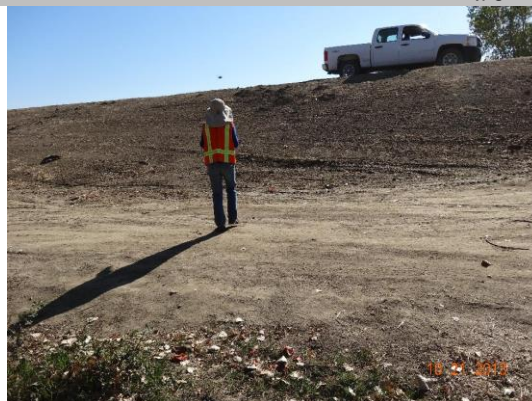
Photo 1 of 2 : UCIP_FA_2016_23506_40806.jpg

Comment Code					
Inspector Comment					
FS_ID:23506 DS_ID:21361 EP_NO: 9944 Repair Type: Non-Urgent Crossing Status: Found UCIP Comments: Burrow activity present on levee slopes. Multiple pipes found on landward side--are these pipes part of original crossing? This crossing is referenced in the USACE Periodic Inspection as item USACE_CESPK_MRD1_2012_p_0291--no USACE recommendation letter available. FIELD_STRUCT_DESC: 18-inch steel pipe through the levee, 21.5 feet below the crown. Gate valve on the waterward end. Discharges into concrete box on the landward side. Rock revetment on waterward slope. This pipe was retained under ABO No. 9944 (1974). FS Date: 10/21/2013

View of waterward side slope and berm.

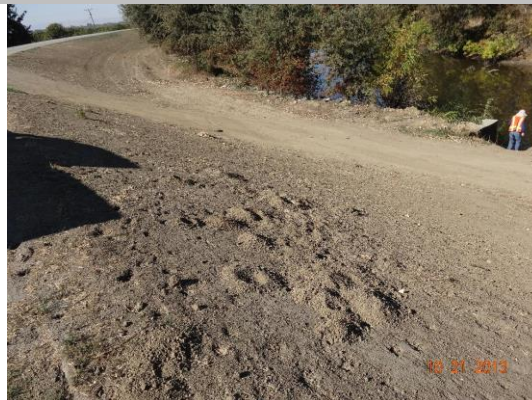
Photo 2 of 2 : UCIP_FA_2016_23506_40801.jpg

Recent burrow activity soil months next to holes.

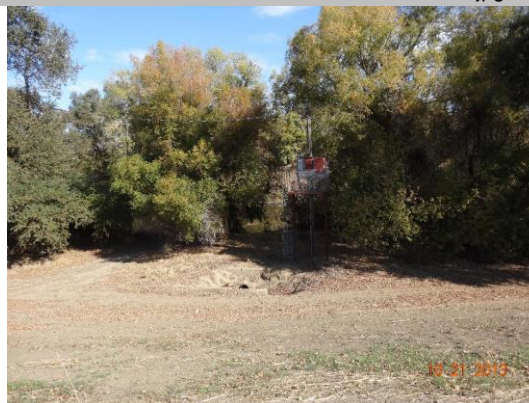
Photo 2 of 2 : UCIP_FA_2016_23510_40838.jpg

Comment Code					
Inspector Comment					
FS_ID:23510 DS_ID:21362 EP_NO: 9944 Repair Type: Non-Urgent Crossing Status: Found UCIP Comments: No pump connection. Need to coordinate with owner to determine status of crossing. If crossing is no longer in use owner will need to contact the CVFPB to comply with Title 23. This crossing is referenced in the USACE Periodic Inspection as item USACE_CESPK_MRD1_2012_p_0183 no USACE recommendation letter available. FIELD_STRUCT_DESC: 18-inch pipe through the levee, 19.5 feet below the crown. Slide gate on waterward end. Pump on waterward side. Concrete distribution box on landward slope. (USACE-1953). This entry matches the Drainage or Irrigation Structure referenced in O&M manual (Station 180+50). This pipe was retained under ABO No. 9944 (1974). FS Date: 10/21/2013

View of waterward side.

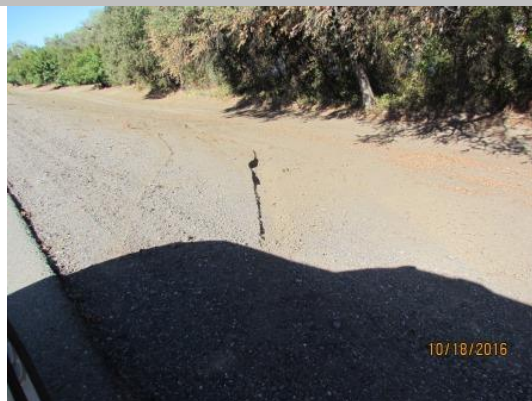
Photo 1 of 1 : FA_2016_RD0070_29_29_20161028_00061.jpg

LM Start	3.72	Rating **	M	Issue No.	29
LM End	3.72	Issue Type +	Ma	Location *	WS
Category	Earthen Levee			GPS Latitude/Longitude	
				Start	End
Item	Slope Stability			39.158183 °	39.158183 °
				-121.888397 °	-121.888397 °
DWR ID	DWR_RD0070_01_f_2016_29				
Comment Code					
S3 : Repair the levee slope damaged by vehicle traffic and prevent access where possible.					
Inspector Comment

View of the ruts along the waterside slope.

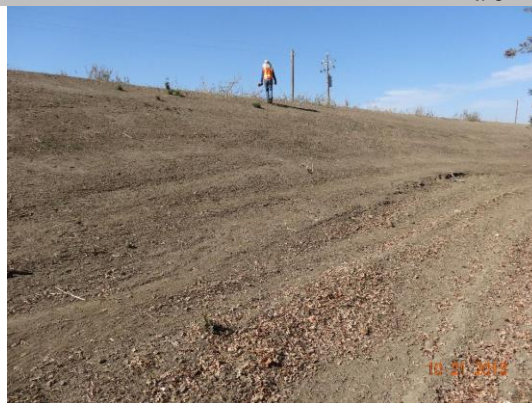
Photo 1 of 2 : UCIP_FA_2016_23515_40867.jpg

Comment Code					
Inspector Comment					
FS_ID:23515 DS_ID:21364 EP_NO: 9954 Repair Type: Non-Urgent Crossing Status: Found UCIP Comments: Power pole down on waterward side. Need to coordinate with owner to determine status of crossing. If crossing is no longer in use owner will need to contact the CVFPB to comply with Title 23. This crossing is referenced in the USACE Periodic Inspection as item USACE_CESPK_MRD1_2012_p_0147. FIELD_STRUCT_DESC: 18-inch (not 24-inch as listed in desk study) steel pipe through the levee, 18.0 feet below the crown. Pipe crosses levee at a 45 degree angle. Slide gate in concrete box (5x5 foot) at waterward toe. Pump in pump house on the waterward side--no pump house found on waterward side. Discharge box at the landward toe. Power pole at the waterward toe. This pipe was retained under ABO No. 9954 (1974). FS Date: 10/21/2013

View of waterward slope.

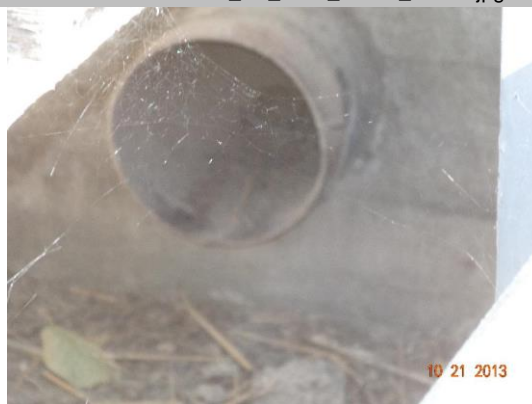
Photo 2 of 2 : UCIP_FA_2016_23516_40872.jpg

Comment Code					
Inspector Comment					
FS_ID:23516 DS_ID:21339 EP_NO: 9951 Repair Type: Non-Urgent Crossing Status: Found UCIP Comments: Need to coordinate with owner to determine status of crossing. If crossing is no longer in use owner will need to contact the CVFPB to comply with Title 23. This crossing is referenced in the USACE Periodic Inspection as item USACE_CESPK_MRD1_2012_p_0144. FIELD_STRUCT_DESC: 10-inch steel pipe through the levee, 16.3 feet below the crown. Pipe crosses levee at a 45 degree angle. Siphon breaker in CM pipe riser on landward slope. Gate valve on waterward end. Discharges into concrete discharge box. This pipe was retained under ABO No. 9951 (1974). FS Date: 10/21/2013

View of pipe on landward side inside concrete distribution box.

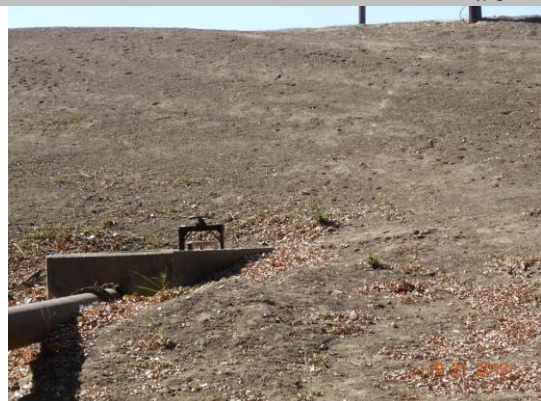
Photo 2 of 2 : UCIP_FA_2016_23518_40887.jpg

FS_ID:23518
DS_ID:21338
EP_NO: 9940
Repair Type: Non-Urgent
Crossing Status: Found
UCIP Comments: No connection present--need to contact owner to determine if owner plans to use. If crossing is no longer in use owner will need to coordinate with DWR inspector and CVFPB to remove according to Title 23 requirements. Unable to determine if crossing is in use. This crossing is referenced in the USACE Periodic Inspection as item USACE_CESPK_MRD1_2012_p_0125.
FIELD_STRUCT_DESC: 18-inch steel pipe through the levee, 19.0 feet below the crown. Cutoff wall around pipe at center of levee. Slide gate in concrete distribution box on landward side. Pump on waterward side. Discharges into concrete box on the landward side. (USACE-1953). This entry matches the Drainage or Irrigation Structure referenced in O&M manual (Station 251+30). This pipe was retained under ABO No. 9940 (1974).
FS Date: 10/21/2013

View of waterward slope.

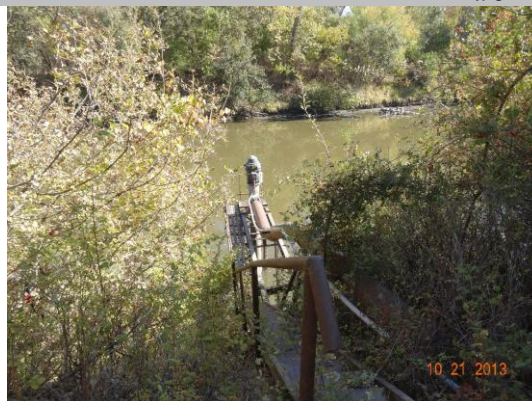
Photo 1 of 2 : UCIP_FA_2016_23519_40896.jpg

LM Start	5.41	Rating **	M	Issue No.	56
LM End	5.41	Issue Type +	En	Location *	LS
Category	Supplemental			GPS Latitude/Longitude	
				Start	End
Item	DWR UCIP Field Study			39.176780 °	39.176780 °
				-121.908025 °	-121.908025 °
DWR ID					
Comment Code					
Inspector Comment					
FS_ID:23519					
DS_ID:21357					
EP_NO: 9957					
Repair Type: Non-Urgent					
Crossing Status: Found					
UCIP Comments: Burrow activity on slopes -- recommend addressing issue. This crossing is referenced in the USACE Periodic Inspection as item USACE_CESPK_MRD1_2012_p_0110.					
FIELD_STRUCT_DESC: 12-inch steel pipe through the levee, 5.5 feet below the crown. Siphon breaker in CM pipe riser on landward slope. Pump on waterward slope. Discharges into concrete box and service pole at landward toe. This pipe was retained under ABO No. 9957 (1975).					
FS Date: 10/21/2013

View of waterward side--pump, pipe, and walkway.

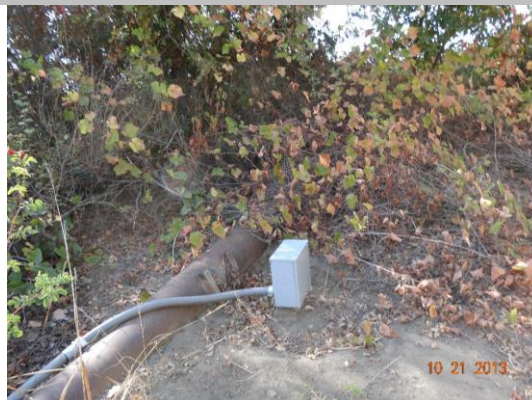
Photo 2 of 2 : UCIP_FA_2016_23519_40898.jpg

Pipe and electrical conduit exposed on levee berm.

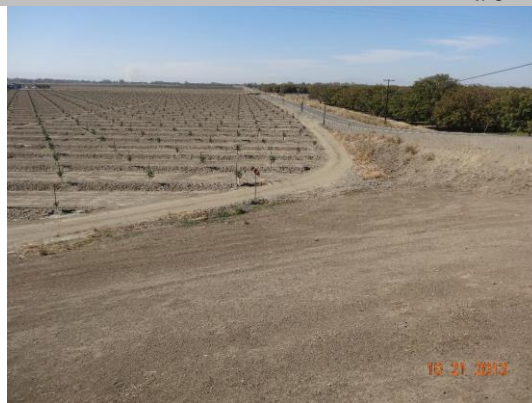
Photo 1 of 2 : UCIP_FA_2016_23479_40724.jpg

LM Start	6.12	Rating **	M	Issue No.	47
LM End	6.12	Issue Type +	En	Location *	LS
Category	Supplemental			GPS Latitude/Longitude	
				Start	End
Item	DWR UCIP Field Study			39.186652 °	39.186652 °
				-121.910549 °	-121.910549 °
DWR ID					
Comment Code					
Inspector Comment					
FS_ID:23479 DS_ID:21360 EP_NO: 4867 Repair Type: Non-Urgent Crossing Status: Found UCIP Comments: Utility marker contact information includes Contact prior to Excavation call 1-800-227-2600 or Emergency Contact 1-800-811-4111. Need to contact owner to determine status of crossing. Need date of last inspection and confirmation that crossing is still in operable condition. FIELD_STRUCT_DESC: 6.5-inch steel gas pipe through the levee, 4.0 feet below the crown. Concrete cutoff wall around pipe at center of levee. Rock revetment on waterward slope. (Permit No. 4867-1966) FS Date: 10/21/2013

View of landward side.

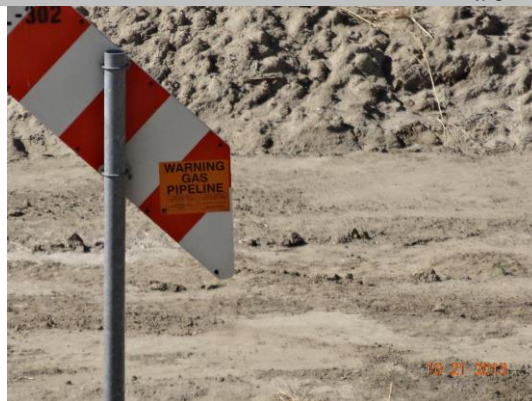
Photo 2 of 2 : UCIP_FA_2016_23479_40723.jpg

Comment Code						
Inspector Comment						
FS_ID:23479						
DS_ID:21360						
EP_NO: 4867						
Repair Type: Non-Urgent						
Crossing Status: Found						
UCIP Comments: Utility marker contact information includes Contact prior to Excavation call 1-800-227-2600 or Emergency Contact 1-800-811-4111. Need to contact owner to determine status of crossing. Need date of last inspection and confirmation that crossing is still in operable condition.						
FIELD_STRUCT_DESC: 6.5-inch steel gas pipe through the levee, 4.0 feet below the crown. Concrete cutoff wall around pipe at center of levee. Rock revetment on waterward slope. (Permit No. 4867-1966)						
FS Date: 10/21/2013

Pipeline marker on landward side.

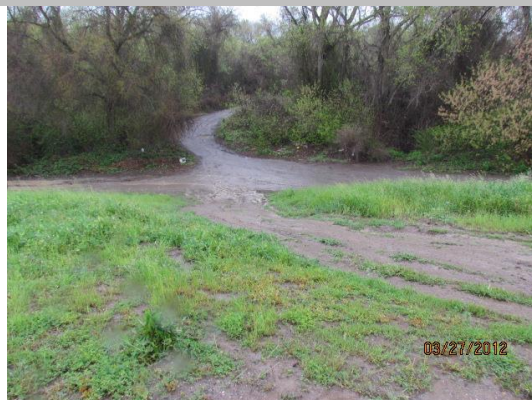
Photo 1 of 2 : FA_2016_RD0070_29_6_20160823_00001.jpg

LM Start	6.18	Rating **	M	Issue No.	6
LM End	6.18	Issue Type +	Ma	Location *	WS
Category	Earthen Levee			GPS Latitude/Longitude	
				Start	End
Item	Slope Stability			39.187481 °	39.187481 °
				-121.910852 °	-121.910852 °
DWR ID	DWR_RD0070_01_s_2012_6				
Comment Code					
S3 : Repair the levee slope damaged by vehicle traffic and prevent access where possible.					
Inspector Comment

View of vehicle erosion along the waterside slope.

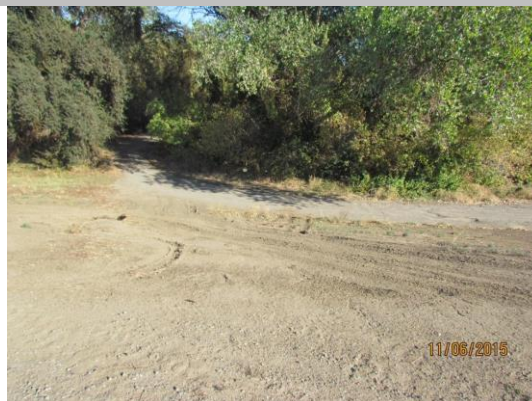
Photo 2 of 2 : FA_2016_RD0070_29_6_20160823_00002.jpg

View of the vehicle erosion along the waterside slope.

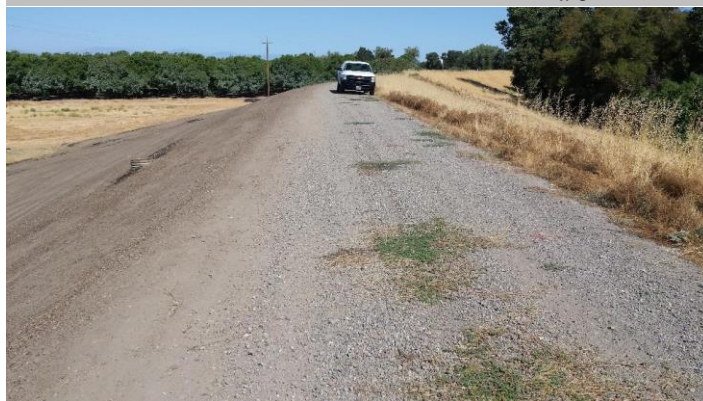
Photo 1 of 2 : UCIP_FA_2016_46422_74619.jpg

Overview of levee crown at crossing. No change from last inspection.

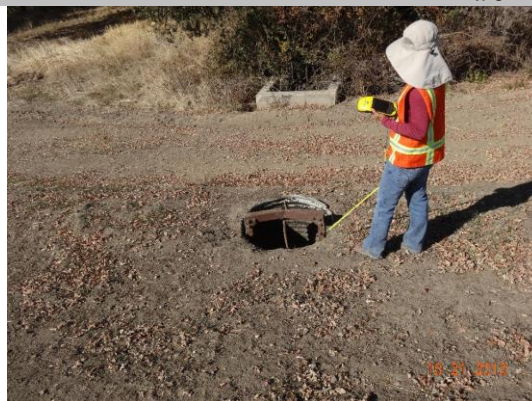
Photo 2 of 2 : UCIP_FA_2016_23529_40963.jpg

CMP riser with screw gate inside. Gate is missing the handle to close gate.

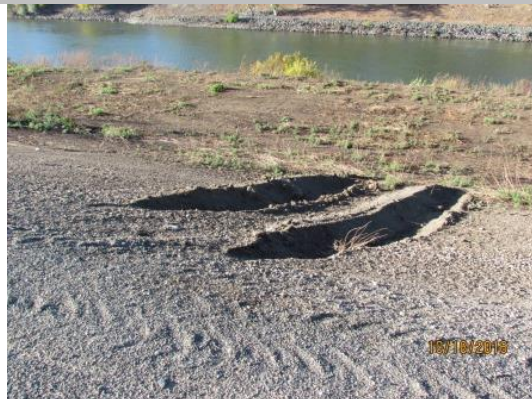
Photo 1 of 1 : FA_2016_RD0070_30_48_20161028_00107.jpg

View of the ruts along the waterside slope.

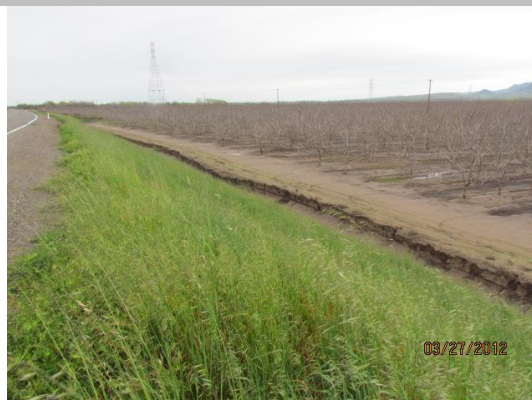
Photo 1 of 1 : FA_2016_RD0070_30_1_20160823_00001.jpg

Agricultural ditch along the landside toe.

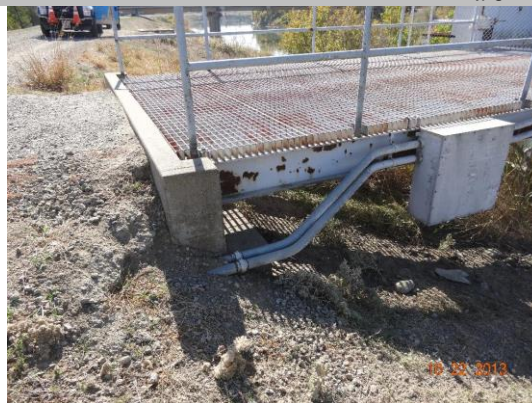
Photo 1 of 1 : UCIP_FA_2016_47028_42570.jpg

Conduits through levee along walkway.

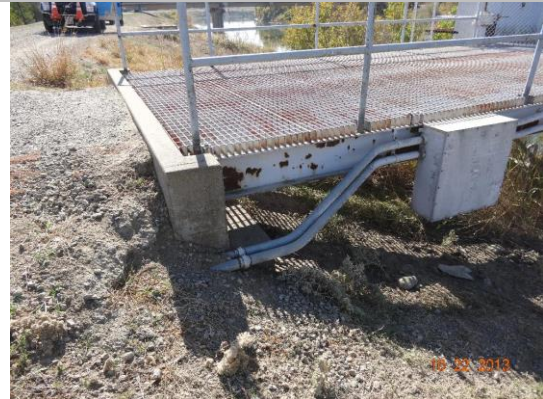
Photo 1 of 1 : UCIP_FA_2016_47029_42511.jpg

Conduits through levee along walkway.

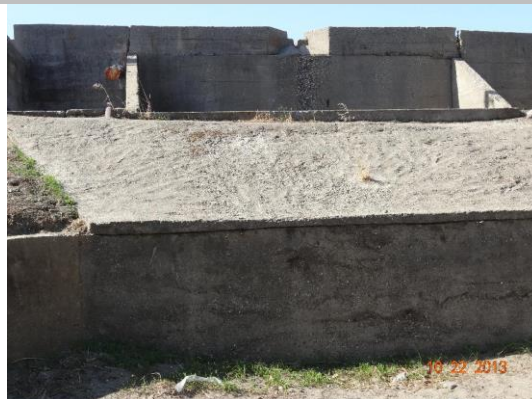
Photo 1 of 1 : UCIP_FA_2016_23959_42096.jpg

Concrete headwall located on landward side--no pipe. Only visible pipe is the pipe located at the far left (downstream end).

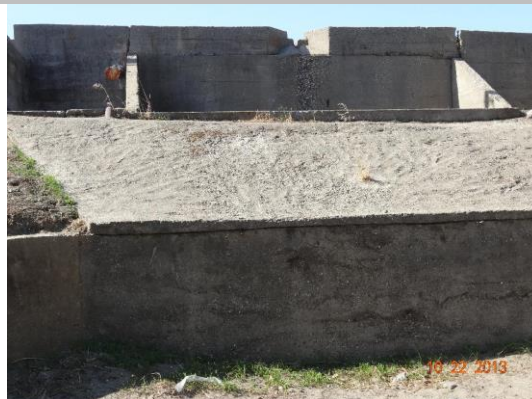
Photo 1 of 1 : UCIP_FA_2016_23960_42097.jpg

Concrete headwall located on landward side--no pipe. Only visible pipe is the pipe located at the far left (downstream end).

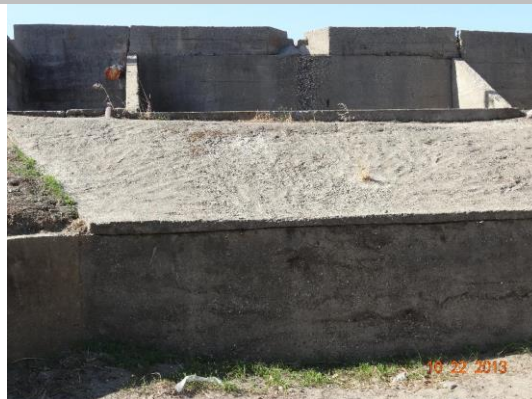
Photo 1 of 1 : UCIP_FA_2016_23961_42098.jpg

Concrete headwall located on landward side--no pipe. Only visible pipe is the pipe located at the far left (downstream end).

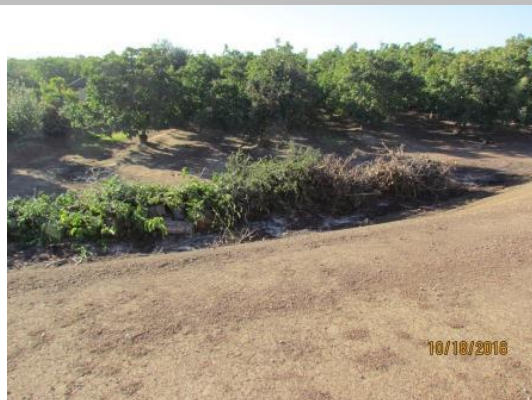
Photo 1 of 1 : FA_2016_RD0070_30_53_20161028_00109.jpg

View of the prunings along the landside toe.

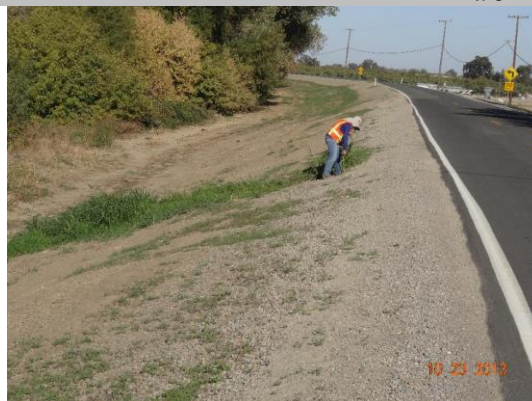
Photo 1 of 2 : UCIP_FA_2016_50007_42684.jpg

Vegetation on WS where leak found.

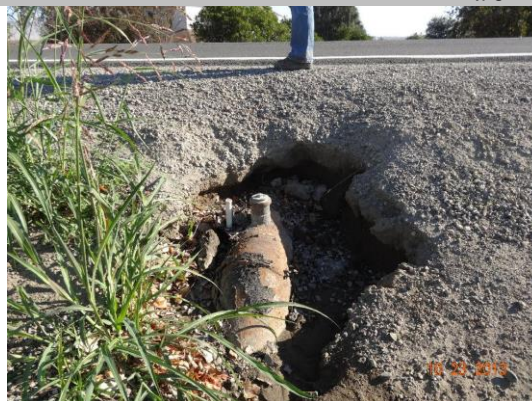
Photo 2 of 2 : UCIP_FA_2016_50007_42680.jpg

Damage to WS shoulder due to leaky pipe or siphon breaker.

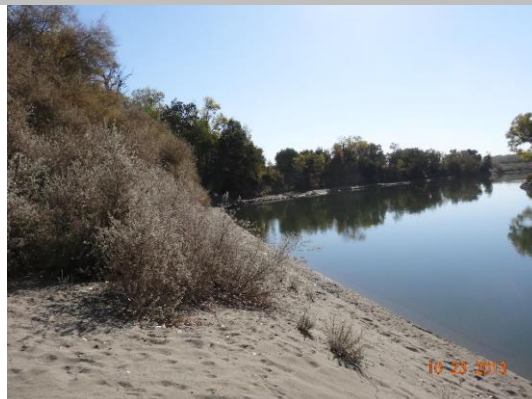
Photo 2 of 2 : UCIP_FA_2016_23967_42132.jpg

No pipe exists levee on waterward side only CMP riser present on landward side.

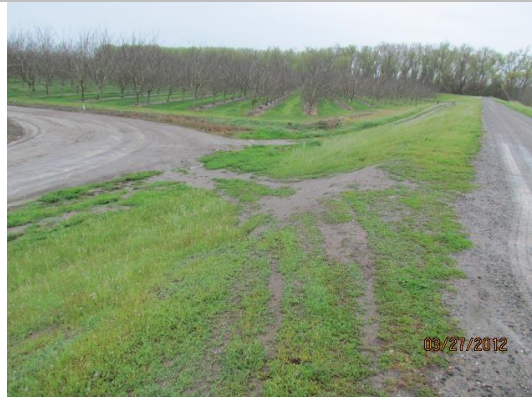
Photo 1 of 1 : FA_2016_RD0070_30_6_20160823_00003.jpg

View of vehicle erosion along landside slope.
